THE LUFTWAFFE SIGNAL SCHOOL KOTHEN

TECHNICAL REPORT ON THE LUFTWAFFE SIGNAL SCHOOL, KÖTHEN

CIOS Target No. 1/91a
Radar

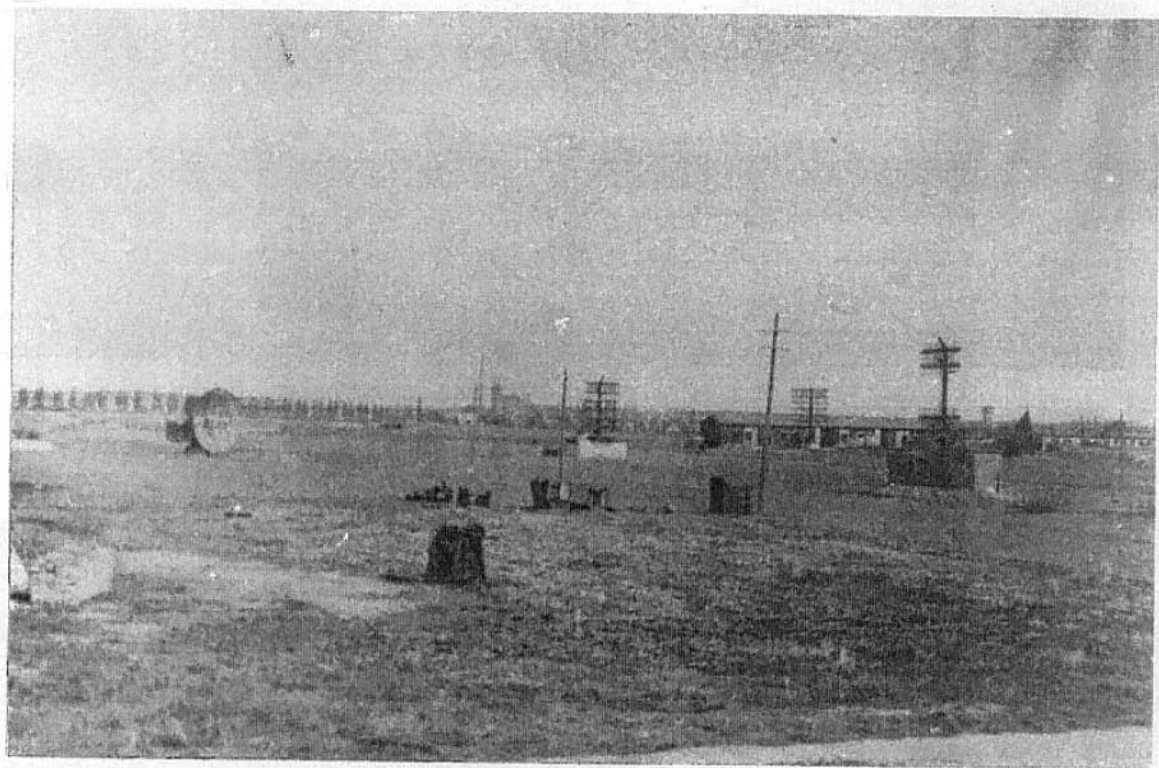
PLATE. I.

Fig. 1 shows the rough layout of these equipments and Plate I shows a general view over the trials field.

All the sets had been deliberately smashed, presumably by the Luftwaffe, and in some cases fires in the cabins had reduced the chassis to molten aluminium.
